FACILITY COMPLIANCE INSPECTION REPORT

Division of Waste Management Solid Waste Section

Miller Farm LCID Landfill
 Miller Farm Road
 Morehead City, NC 28557

Site visit to review measures taken in response to 19 December 2011 fire event

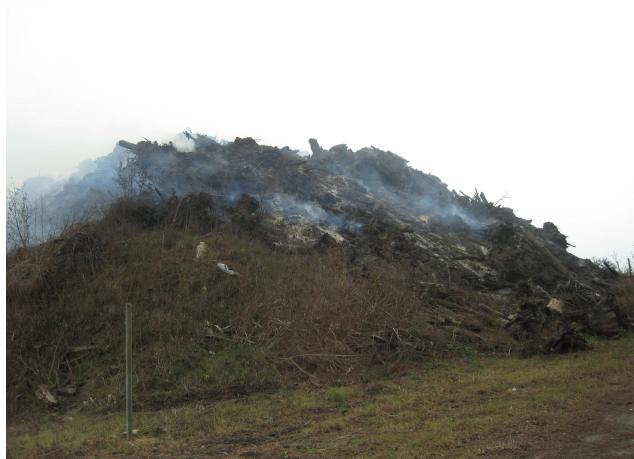
Landfill sideslope cover crop and cap damaged by fire and excavator.

- 17) *As soon as is safely practicable, please resume compacting and covering the cap and sideslopes damaged during fire incident.
- 18) Digital photographs were taken during this audit; *please see photographs attached below.*

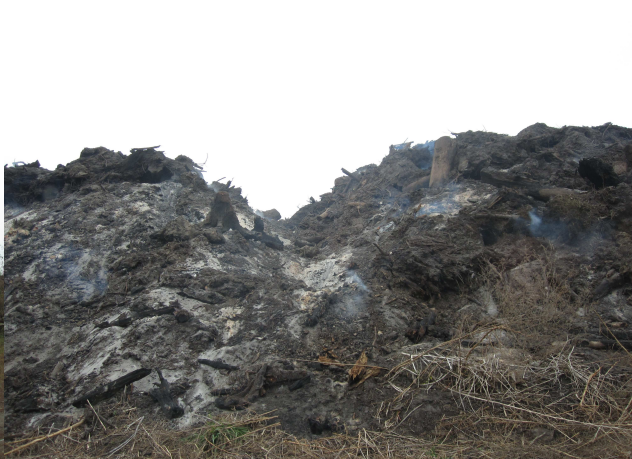
- 12) Carteret County Emergency Services reports that this landfill caught fire on Monday 19 December 2011. Local emergency responders arrived on-site and pumped water onto the landfill while the facility operator used an excavator in an attempt to dig a trench around the burning area to isolate the fire from the rest of the facility. The fire spread too quickly for the operator to contain it and he removed the excavator from the area for safety. The firefighters continued spraying water onto the facility until they deemed that the fire had been contained. They advised the operator not to take heavy equipment or personnel onto the landfill due to the danger of cave-in. The operator was also advised to monitor the fire while allowing it to burn itself out.

Area on the sideslope where operator attempted to trench around the fire.

- 15) There were no fire-fighting activities ongoing during this site visit.
- 16) *As soon as is safely practicable, please resume pumping water onto the landfill, with specific attention being given to the areas where smoke and/or flames are noted as emanating from the landfill cap. In past similar events, excavating these "hot" areas and dousing them directly with water has proven to be the most effective way of fighting these types of fires.

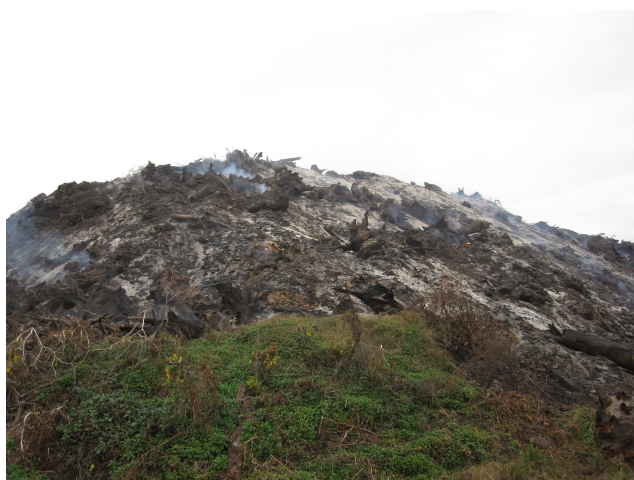
Landfill sideslope cover crop and cap damaged by fire and excavator.

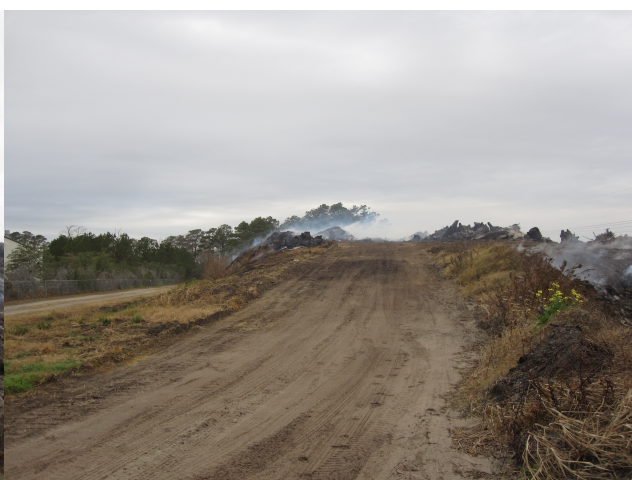
Access ramp to top lift.
